## **Work Completion Report**

Medi-Clean Solutions | 14/01/2021

### Work Compleation Report

### System 01-19 – Roof Unit's

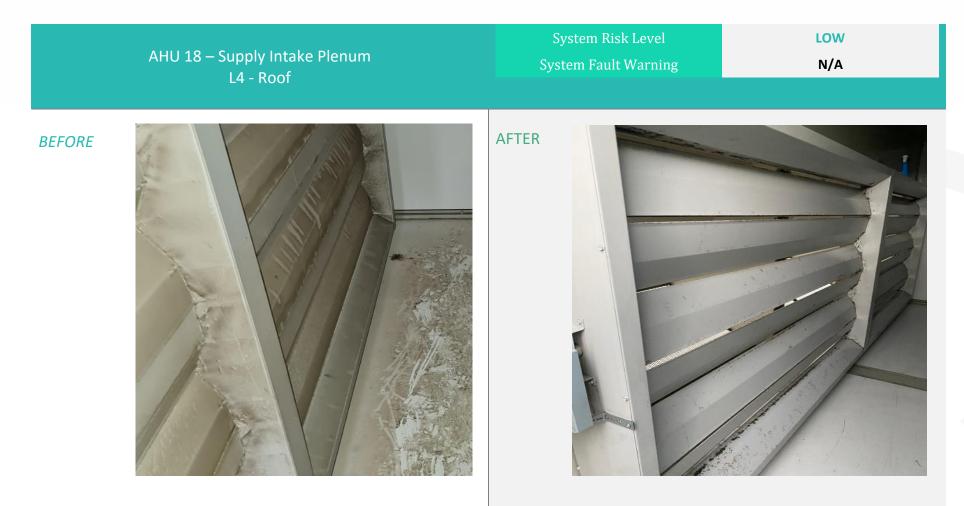
AHU 18 – Supply Intake Plenum	System Risk Level	LOW
L4 - Roof	System Fault Warning	N/A
<section-header></section-header>	AFTER

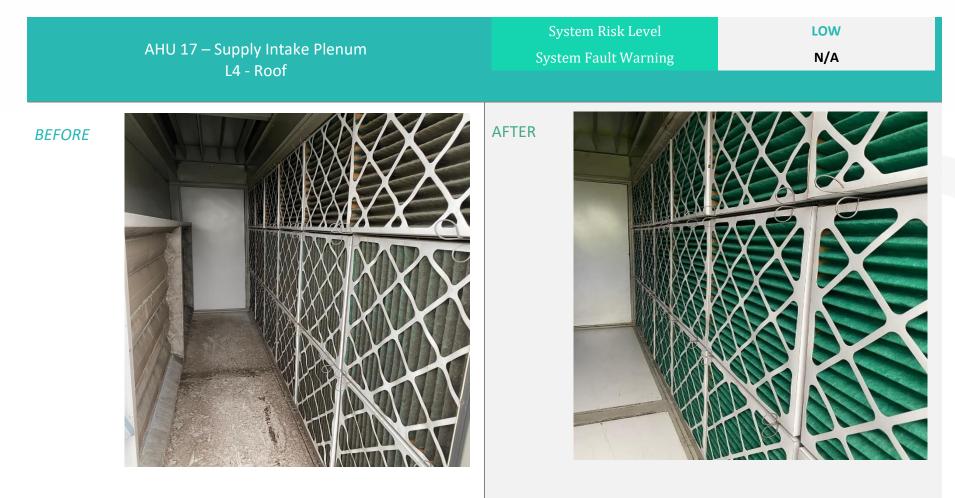
AHU 17 – Supply Intake Plenum	System Risk Level	LOW
	L4 - Roof	System Fault Warning	N/A
BEFORE		AFTER

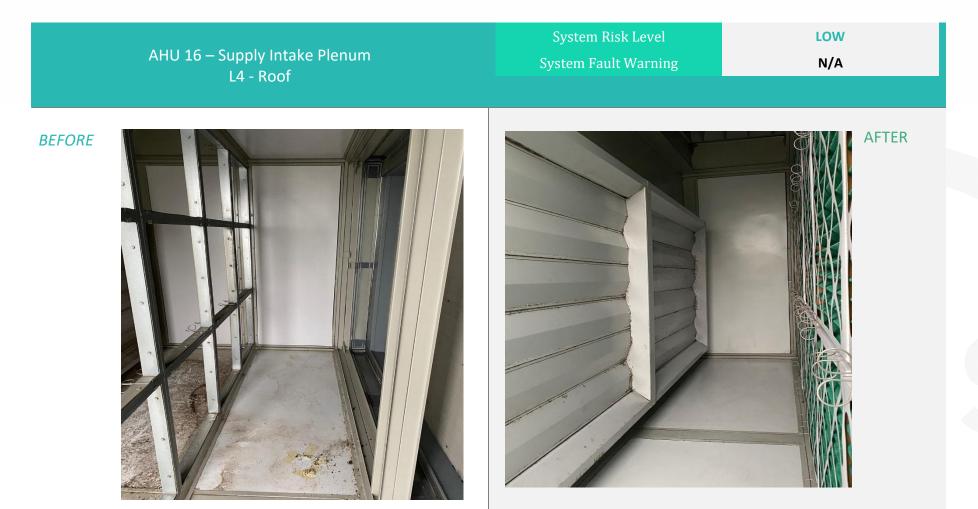
AHU 16 – Supply Intake Plenum	System Risk Level	LOW
L4 - Roof	System Fault Warning	N/A
<section-header></section-header>	AFTER

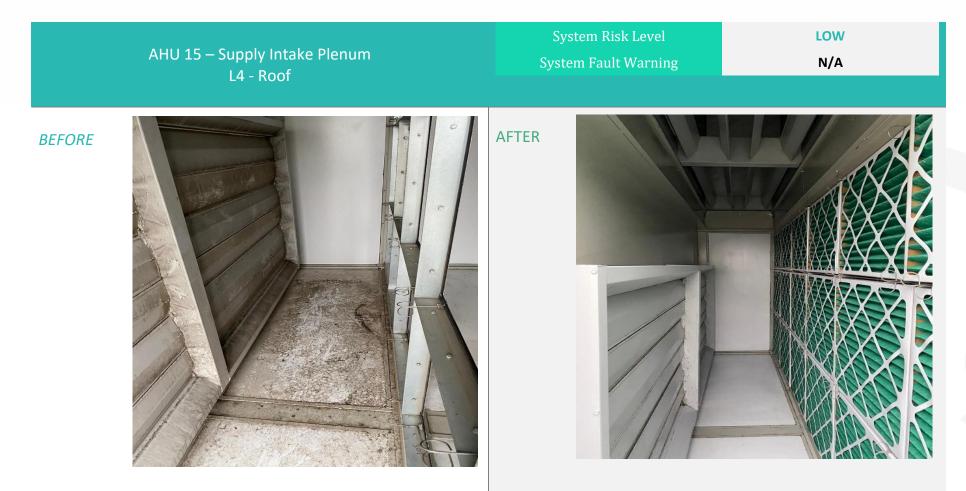
info@medicleansolutions.co.uk		
	AHU 15 – Supply Intake Plenum L4 - Roof	System Risk Level System Fault Warning	LOW N/A	
BEFORE	<image/>	AFTER

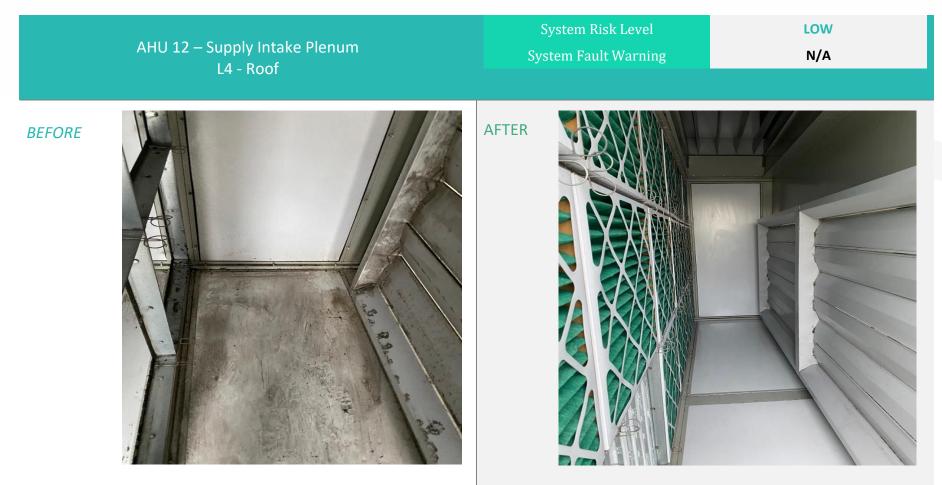
AHU 12 – S	upply Intake Plenum L4 - Roof		em Risk Level n Fault Warning	LOW N/A
		AFTER

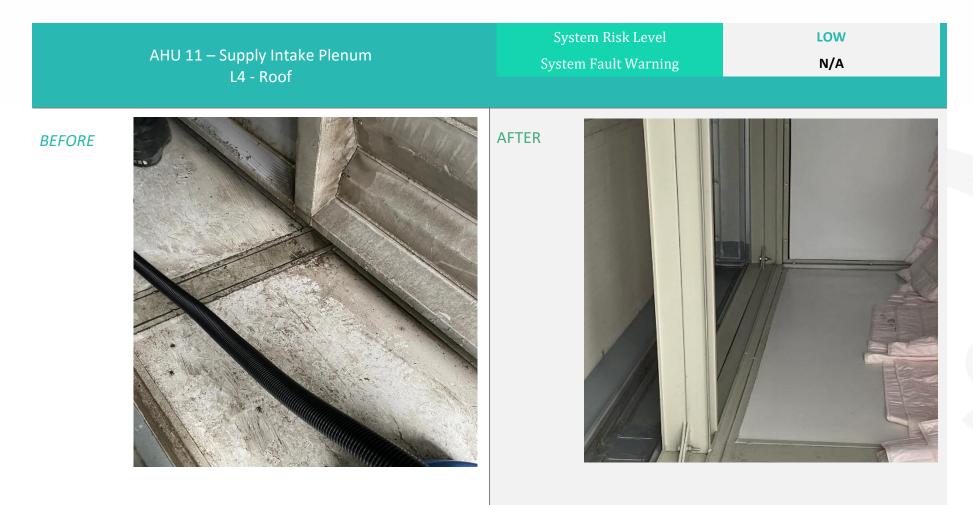
AHU 11 – Supply Intake Plenum	System Risk Level	LOW
L4 - Roof	System Fault Warning	N/A
<section-header></section-header>	AFTER

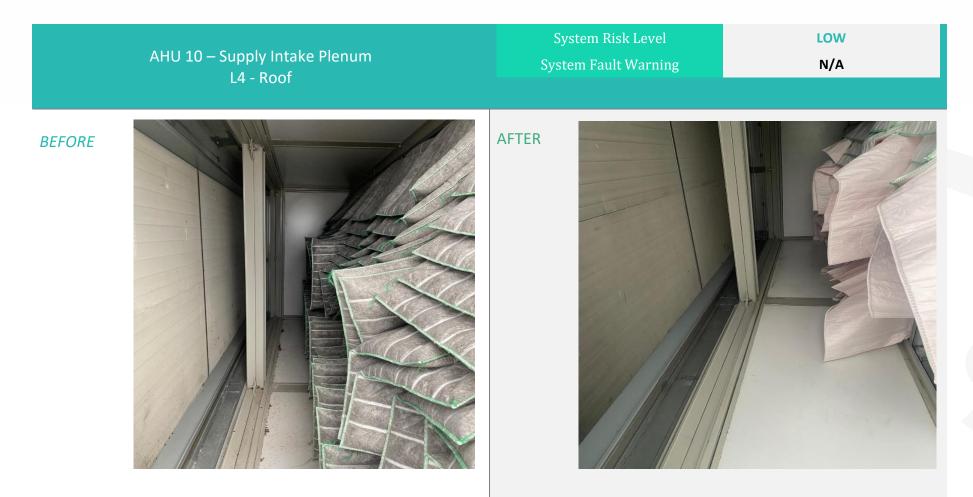
AHU 10 – Supply Intake Plenum	System Risk Level	LOW
L4 - Roof	System Fault Warning	N/A
<section-header></section-header>	AFTER

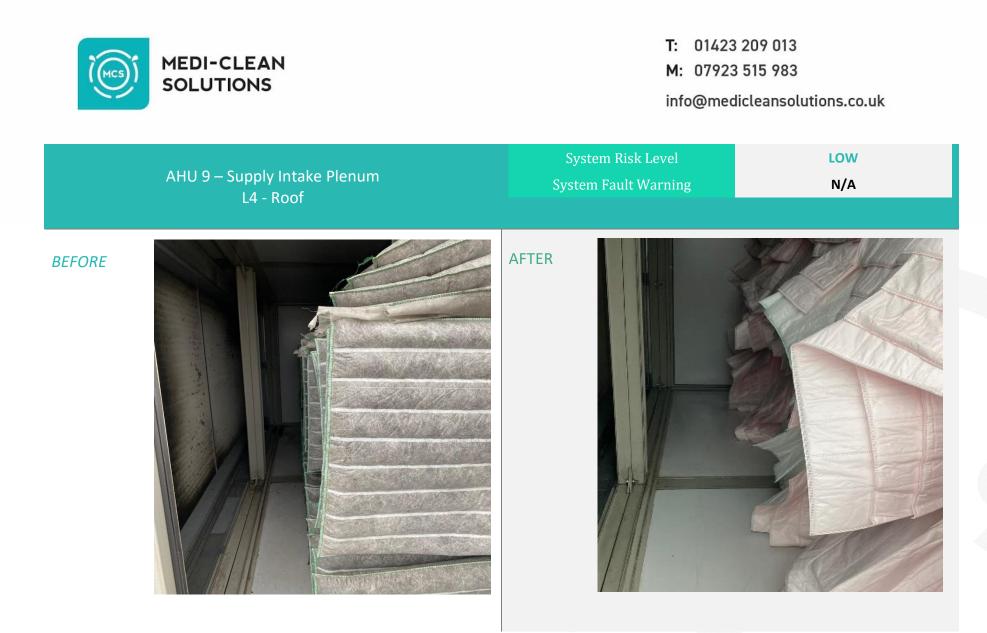
AHU 9 – Supply Intake Plenum	System Risk Level	LOW
L4 - Roof	System Fault Warning	N/A
<section-header></section-header>	AFTER

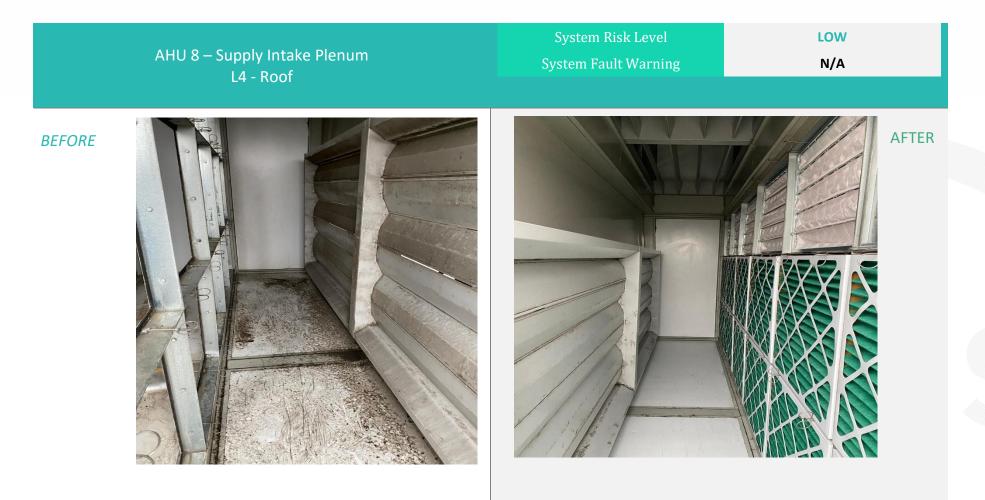
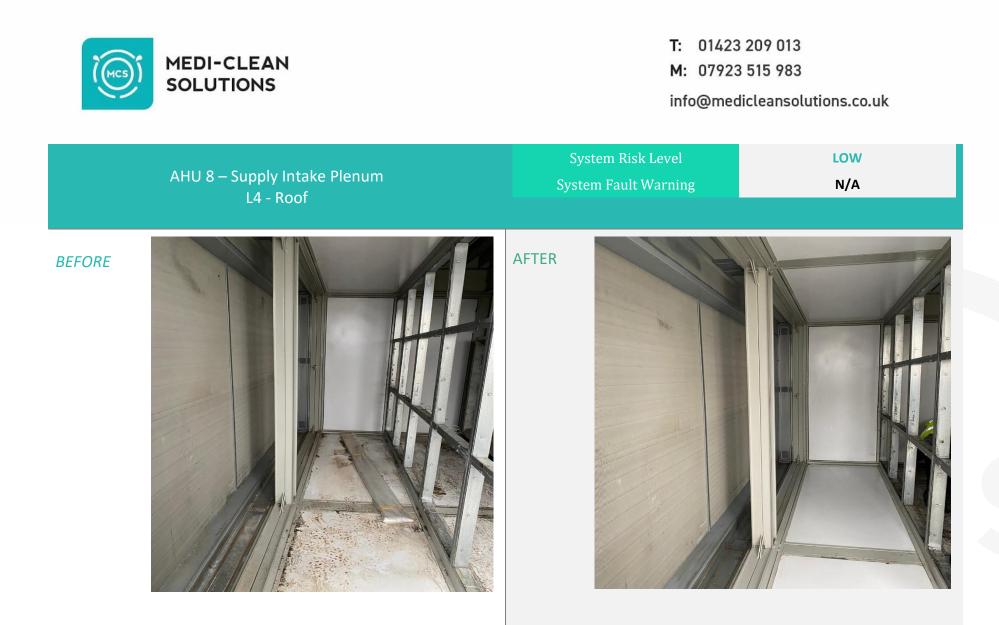
AHU 8– Supply Intake Plenum	System Risk Level	LOW
	L4 - Roof	System Fault Warning	N/A
BEFORE		AFTER

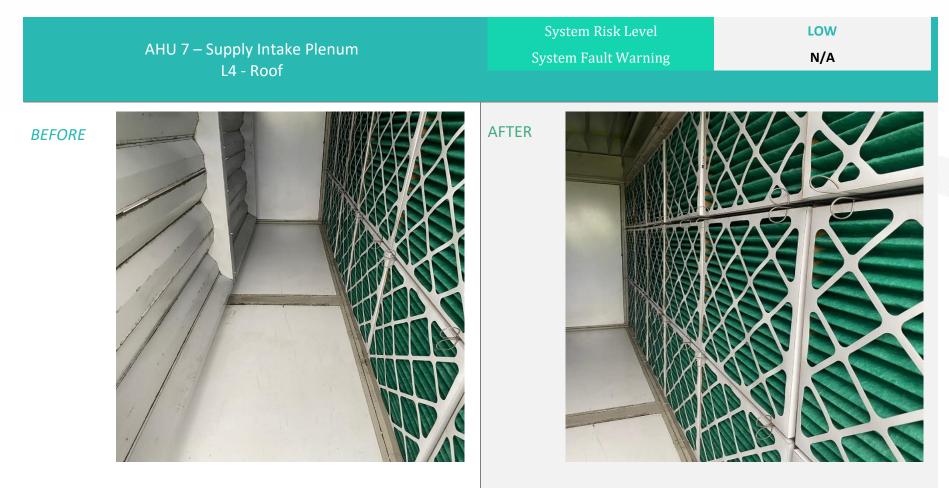
AHU 7 – Supply Intake Plenum	System Risk Level	LOW
L4 - Roof	System Fault Warning	N/A
<section-header><section-header></section-header></section-header>	AFTER

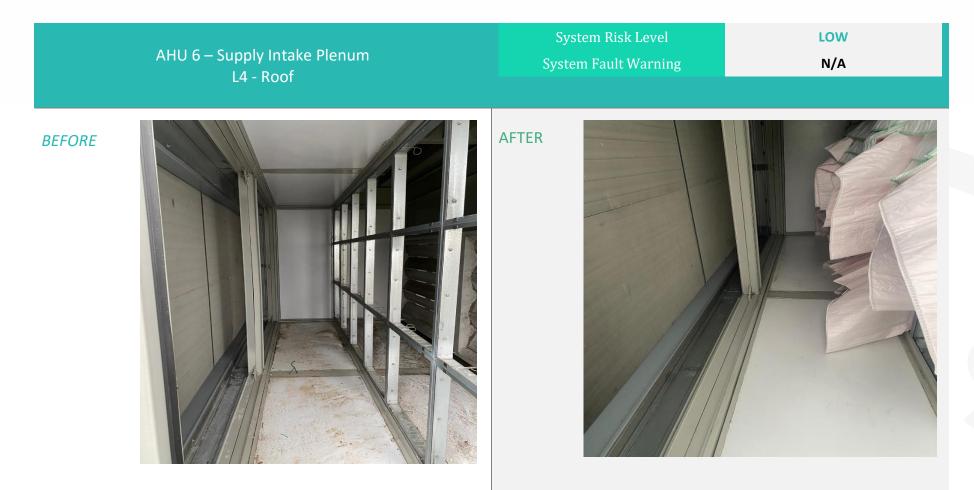
AHU 6 – Supply Intake Plenum	System Risk Level	LOW
L4 - Roof	System Fault Warning	N/A
<section-header></section-header>	AFTER

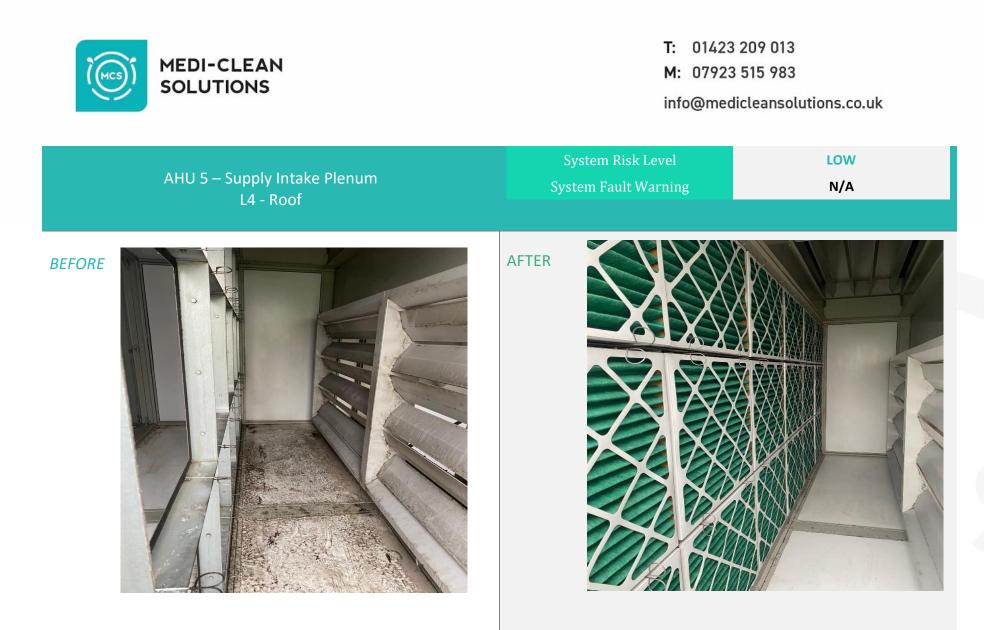
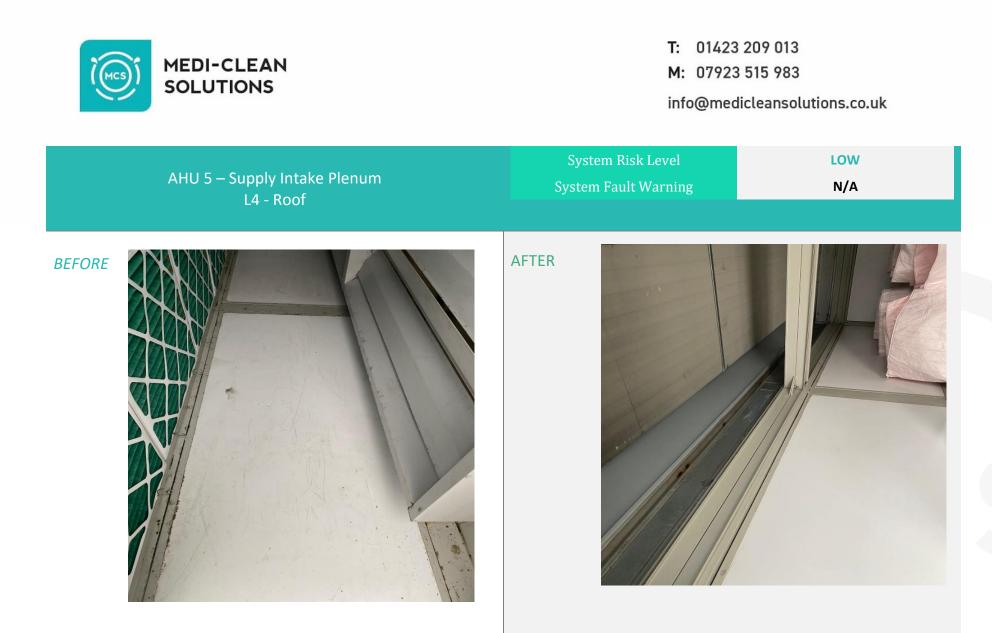
AHU 5 – Supply Intake Plenum	System Risk Level	LOW
	L4 - Roof	System Fault Warning	N/A
BEFORE		AFTER

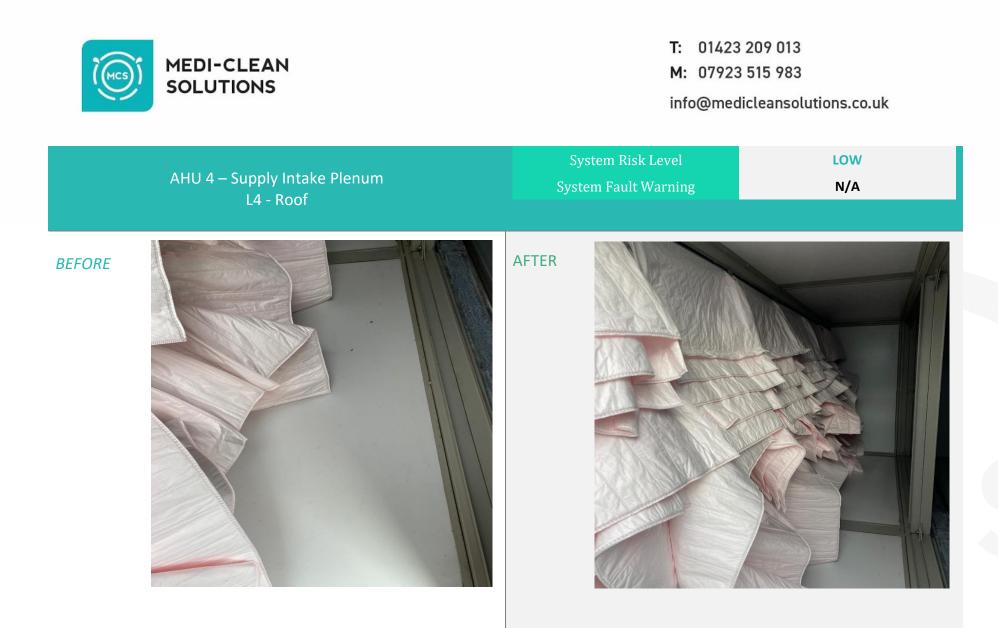
AHU 4 – Supply Intake Plenum	System Risk Level	LOW
L4 - Roof	System Fault Warning	N/A
<section-header></section-header>	AFTER

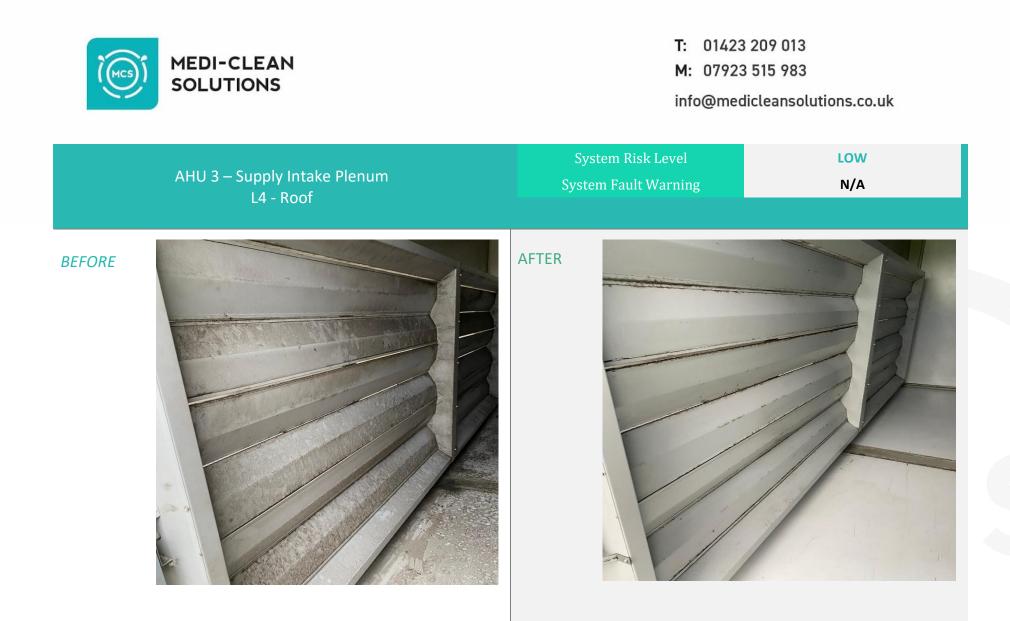
AHU 3 – Supply Intake Plenum L4 - Roof		vstem Risk Level eem Fault Warning	LOW N/A
BEFORE		AFTER

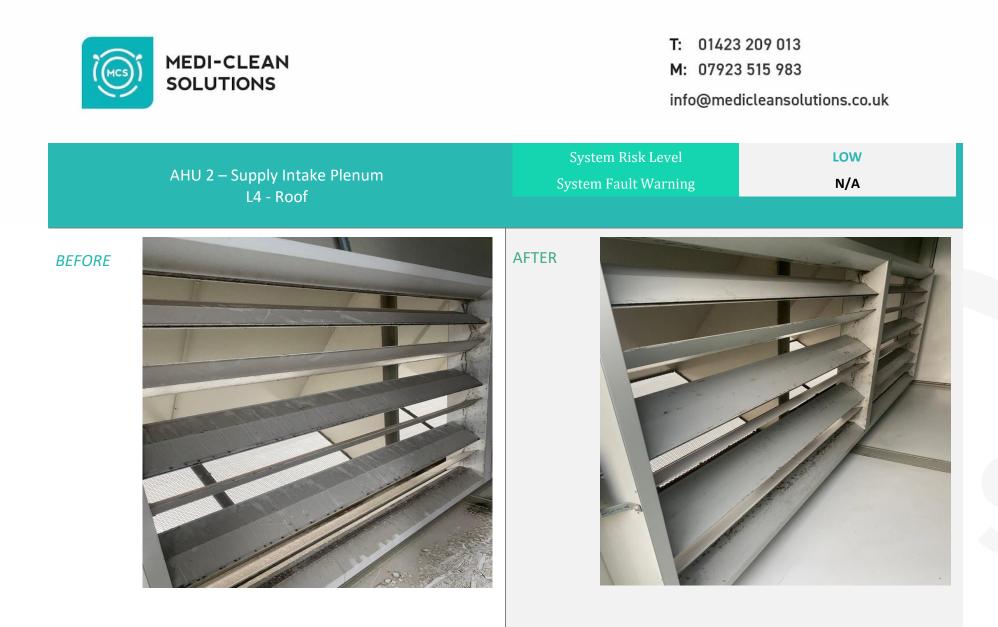
integrited	
	AHU 2 – Supply Intake Plenum L4 - Roof		System Risk Level stem Fault Warning	LOW N/A
BEFORE	<image/>	AFTER

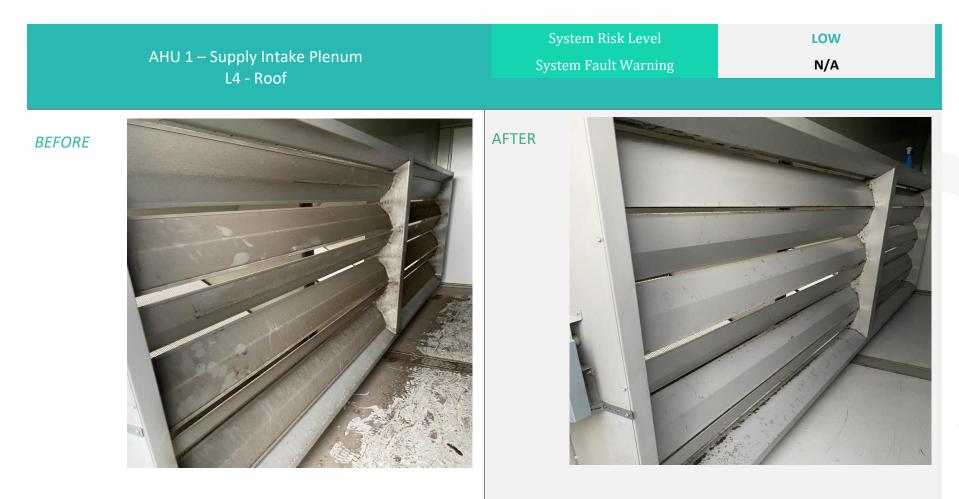
AHU 1 – Supply Intake Plenum	System Risk Level	LOW
	L4 - Roof	System Fault Warning	N/A
BEFORE		AFTER
